Evaluation of automated UVC disinfection systems in acute care hospitals

Jewish General Hospital,

2023

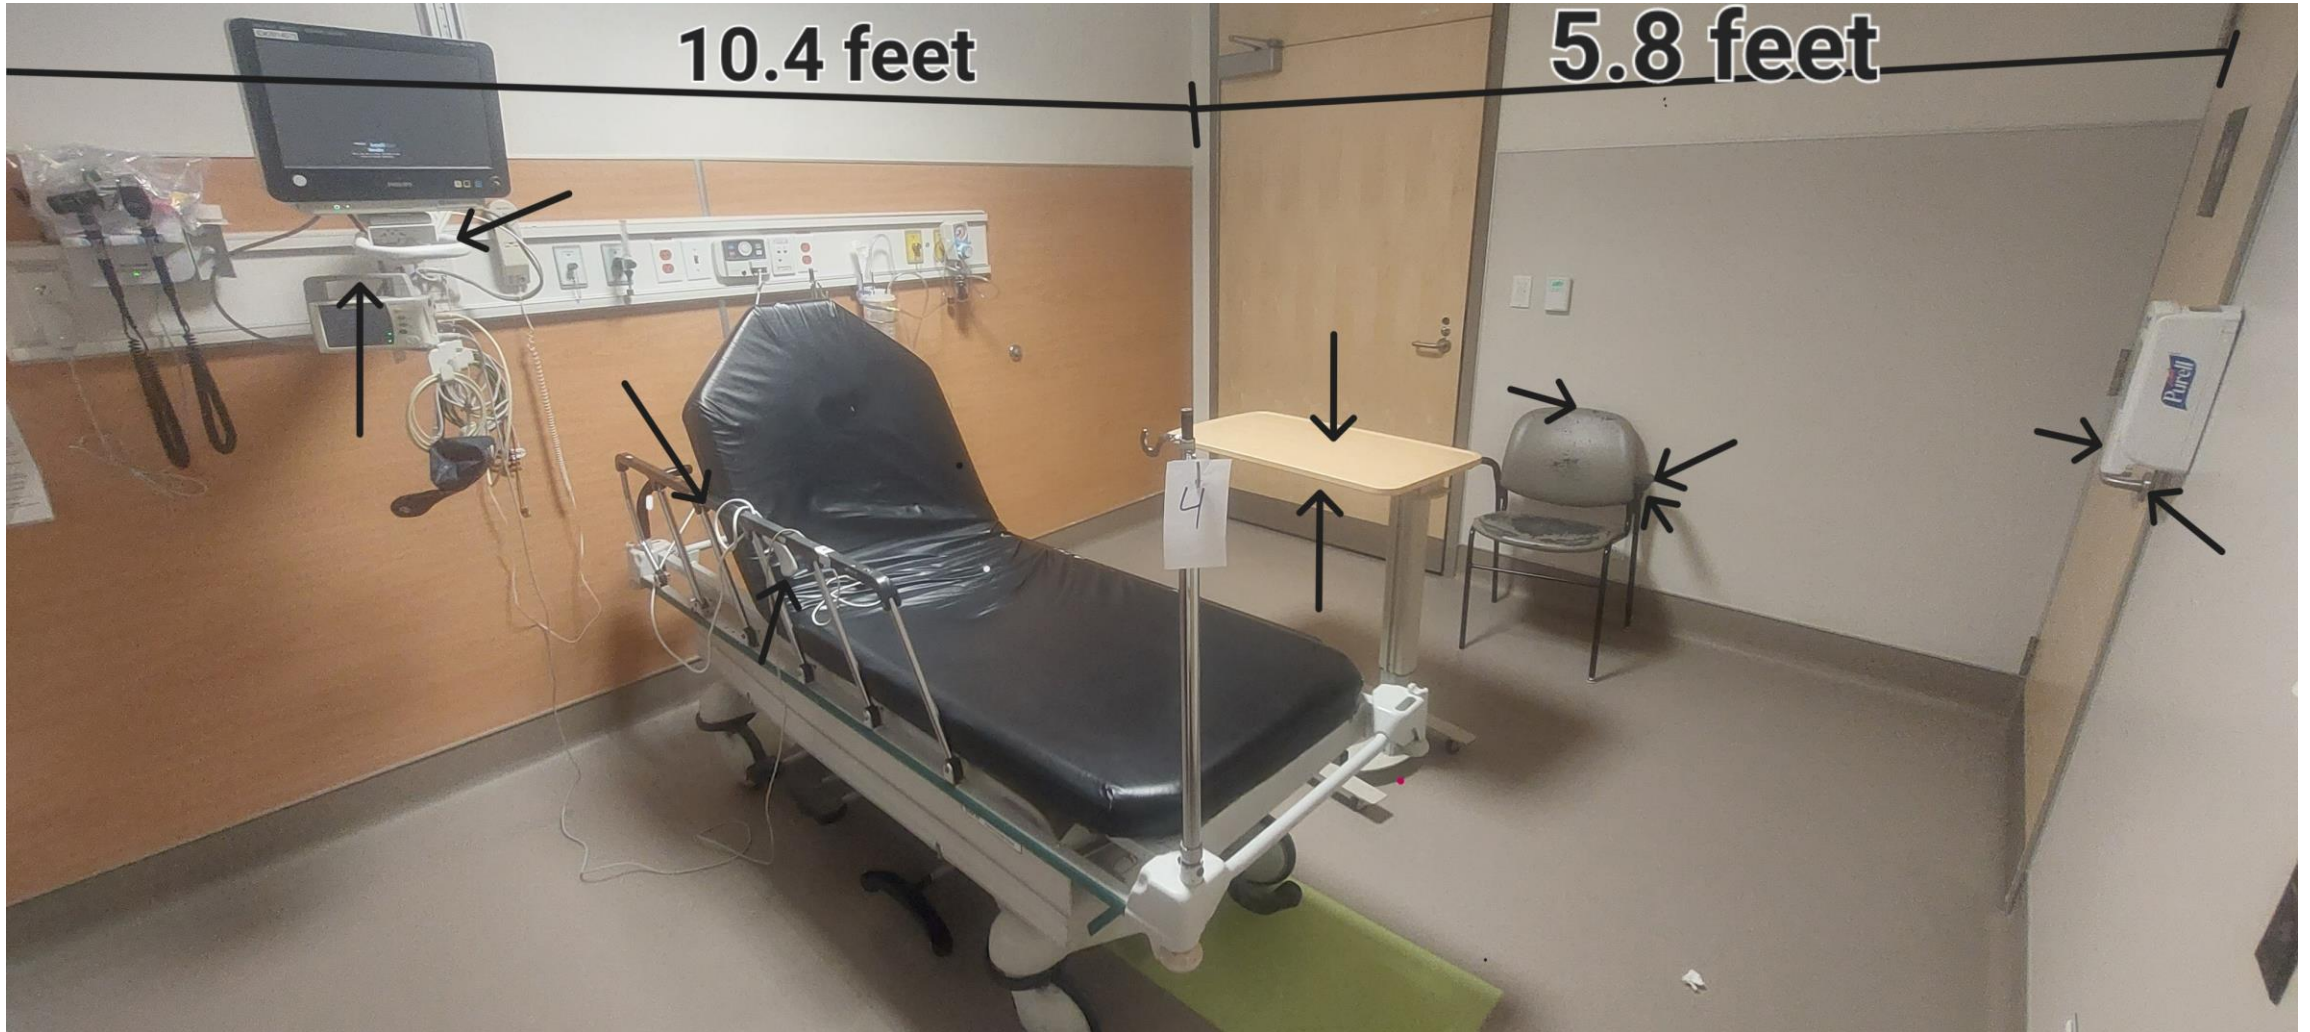
- Location: 3 rooms in ED (green 4, orange 16 and yellow 20)
- 14 sites per room (not only high touch)

- Bacterial growth assessed by using contact plates incubated 37C x 18-24hrs
- Quantification and identification of bacteria recovered

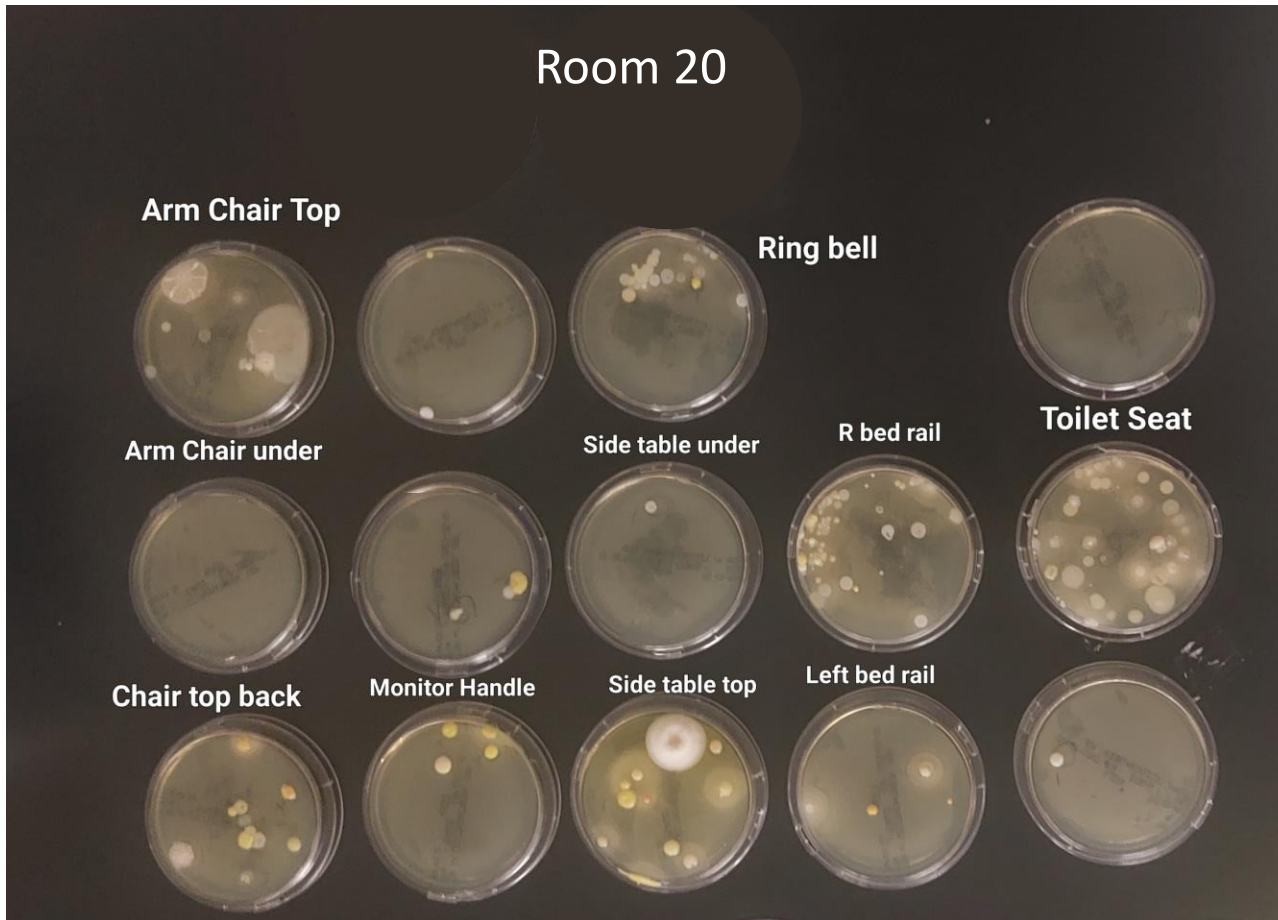
1. Right side bed rail
2. Left side bed rail
3. Ring bell
4. Side table (Top)
5. Paper dispenser handle
6. Monitor Handle
7. Screen Intelli-View
8. IV pole Handle
9. Hand sanitizer
10. Chair (Top back)
11. Arm Chair (Under)
12. Arm chair (Top)
13. WC Door Handle
14. Toilet seat

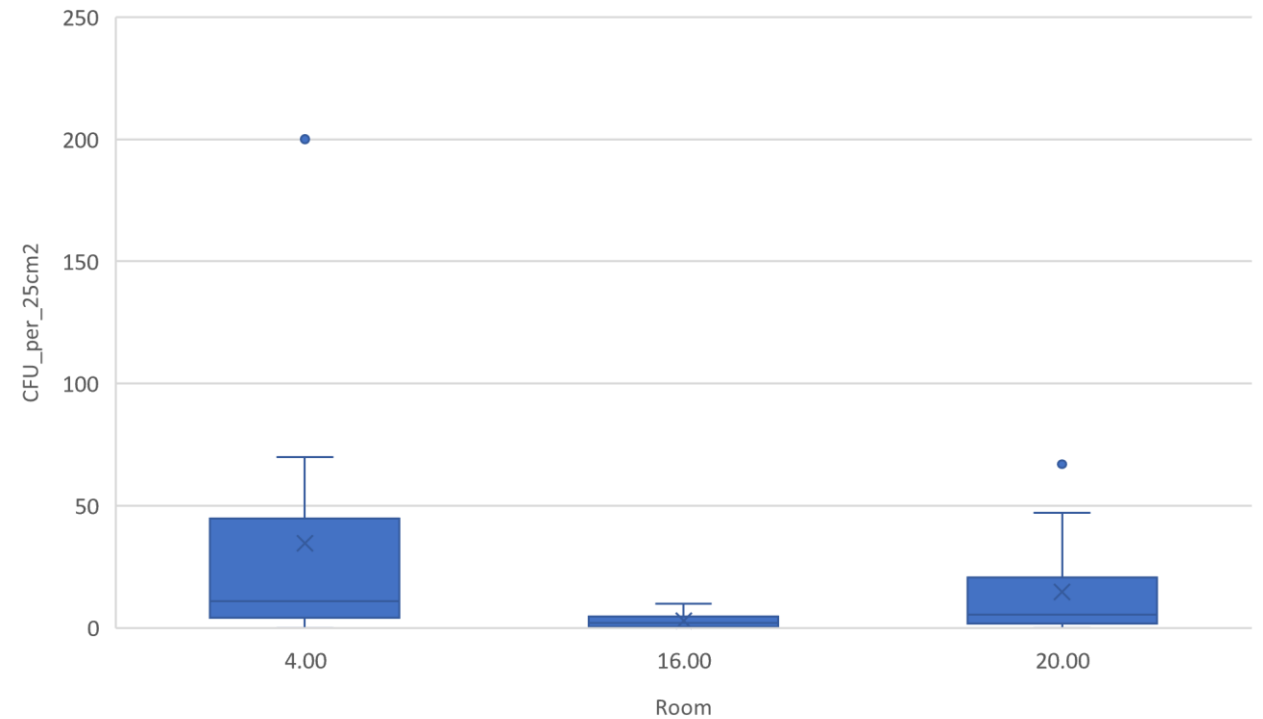
- Duration of patient stay in rooms prior to discharge:
 - 13h, 17h and 14h
- Bacterial load: median, 5 CFU/ 25cm² (IQR, 2 to 13 CFU/25cm²)
 - Room 4: 11 CFU/25cm²
 - Room 16: 2 CFU/25cm²
 - Room 20: 6 CFU per 25cm²
- Some areas heavily contaminated
 - Toilet seat TNTC
 - Bed rail 67 CFU/25cm²
- Most bacteria recovered = non-pathogens
 - E.g. *M luteus*, *Corynebacterium*, *Staph sp*
- 4 pathogens (10% of samples)
 - *Pantoe agglomerans* (2), *E cloacae*, *Moraxella osloensis*

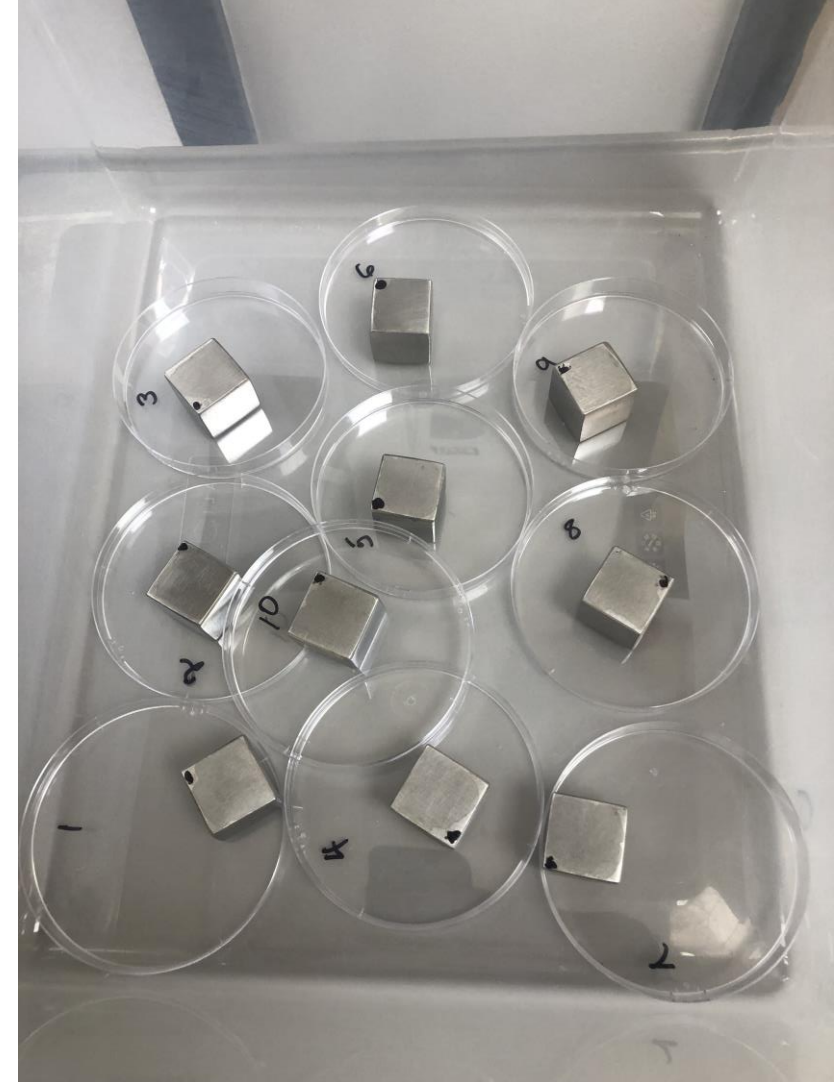
- **Stainless steel cubes contamination**
 - A single surface contaminated with approx 10×10^7 CFU *S aureus*
 - Placement of contaminated stainless steel cubes in strategic locations in the room
 - Effectiveness of disinfection assessed by calculating the residual bacterial load on the test cube compared with an unexposed control
 - Sampling of cubes: by immersion in sterile bag and serial dilution on blood agar plates

- 1 Right bed side rail (Top)
- 2 Right bed side rail (facing the device)
- 3 Right bed side rail (facing the other side of the device)
- 4 left bedside rail
- 5 Cardiac Monitor Handle
- 6 Intellivue
- 7 bathroom door handle
- 8 Overhead table (Top)
- 9 Chair handle (top)
- 10 Chairback (facing the device)
